Preservation in Progress: Filling Cracks in Monticello's Wall Panels

by Lucy Midelfort - April 24, 2019

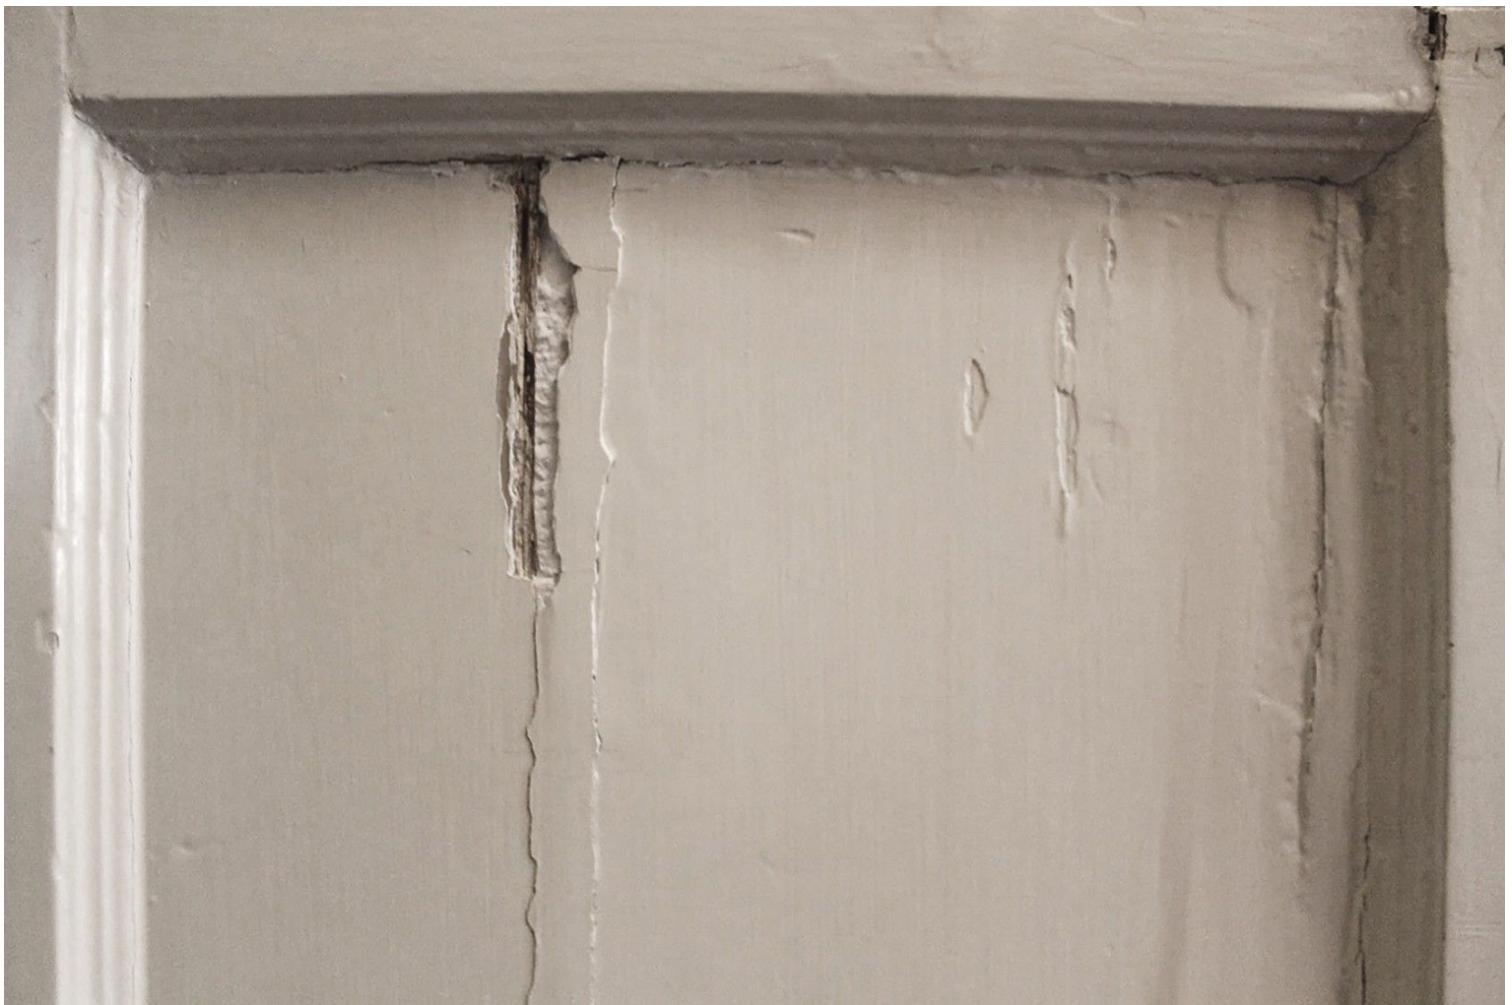
In the case of these panels, the prior fill has separated from the rest of the panel over years and it is time to begin again. Repairs like these along with touching up paint, polishing the Parlor's parquet floor, repairing plaster, and ensuring door locks are in good working order, are typical of the work done by Monticello's Restoration Department.

A previously filled crack in the door surround between the Parlor and Dining Room, before treatment.

The first step of the process is to carefully remove the old fill material and brush on a reversible, thermoplastic resin—we use Paraloid B72, a favorite among art and architecture conservators—to isolate and protect the Jefferson-era wood.

Next we infill the wider portions of the crack or gap with lightweight balsa wood, which gets secured with fish glue also chosen for its reversibility. Any tiny cracks on either side of the balsa are then stuffed with cotton soaked in reversible B72.

The final step involves applying a chalk-based wood filler to the surface, making sure it lies flat. Then, all that's left is to prime and paint. The result is a smooth surface with the original material is carefully protected underneath.

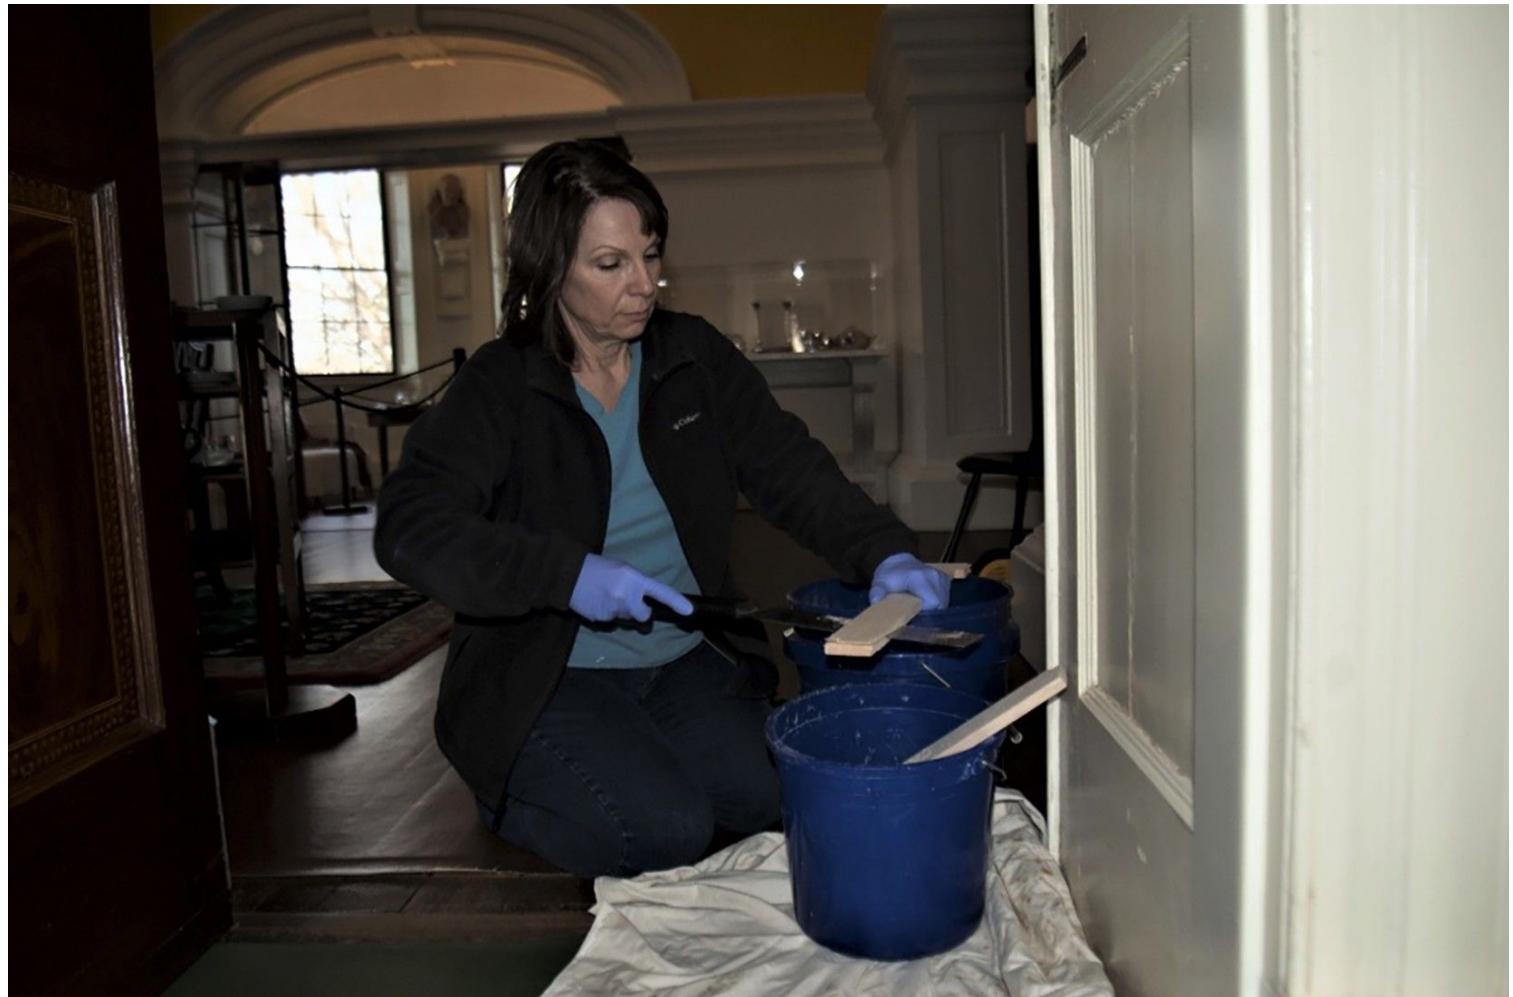
Restoration Specialist Carol Richardson cutting balsa wood to fill the wider portions of the crack.
